DeltaV-Seal 316L

The impact of using DeltaV-Seal™ on flange surfaces

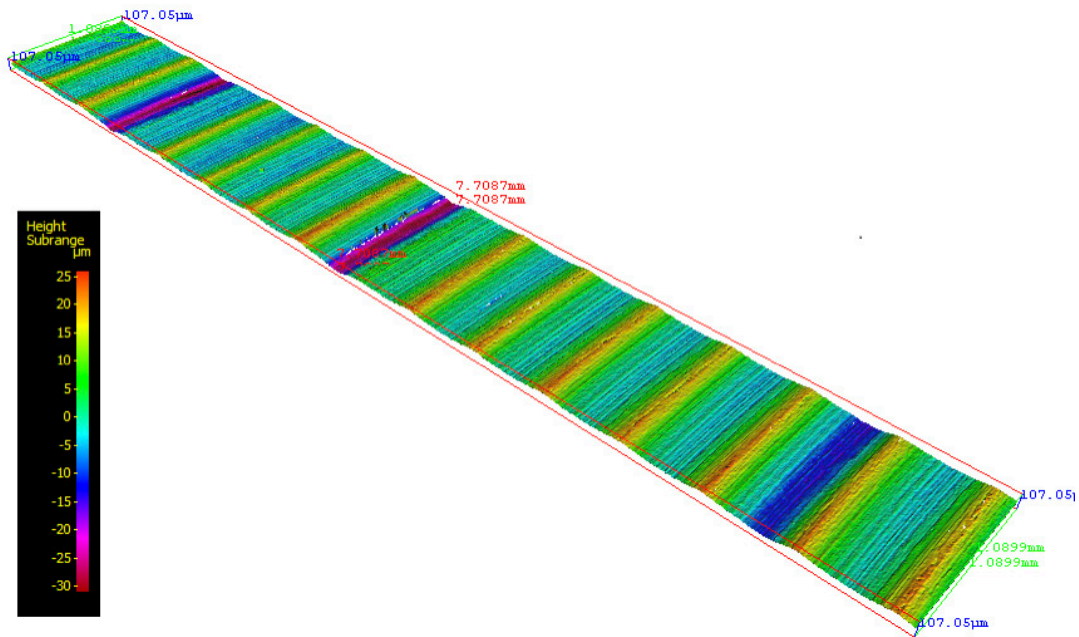
Colour-coded 3D surface profile variation visualization showing concentric flange grooves and three locations of DeltaV-Seal interaction with the flange surface. Purple colour: max. depth 30 µm; Red colour: max. height 25 µm.

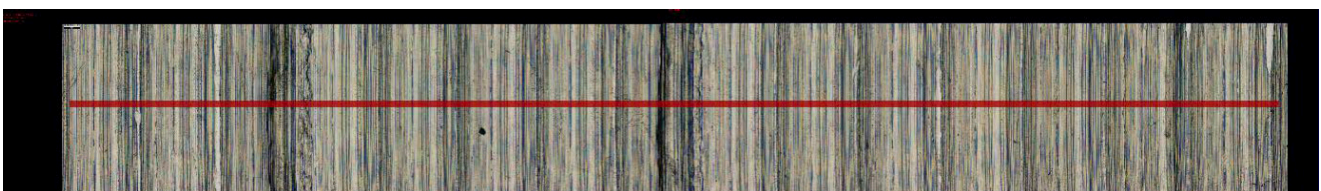
Optical image of a 1" flange RF surface with the measurement line in red across with a radial distance of 6 mm between the visible outer and inner ridge interaction locations.

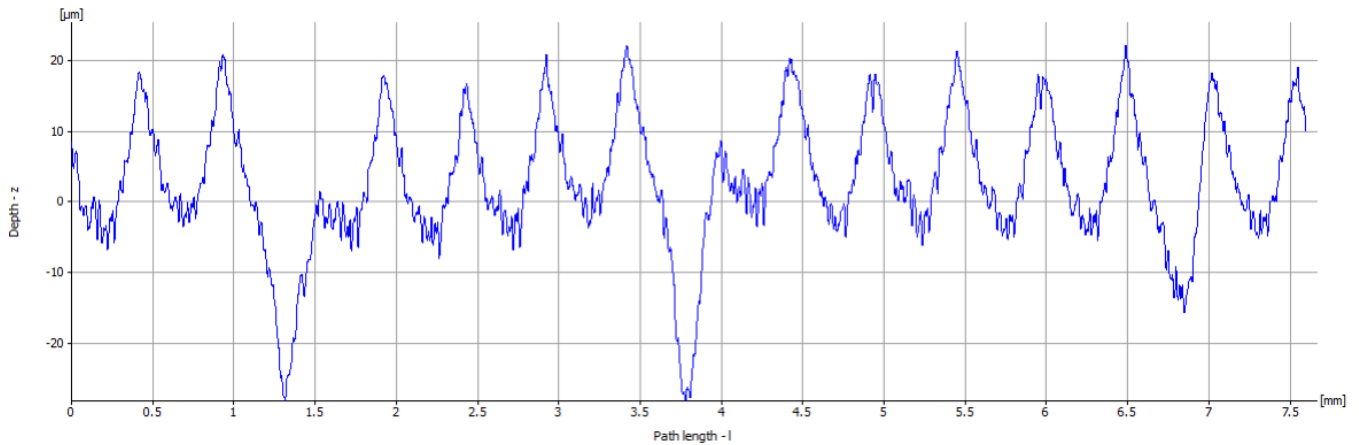
Typical flange surface profile of the tested flanges with the three DeltaV-Seal interaction locations clearly visible in-between the machined grooves with a radial distance of 6 mm between the inner and outer ridge gasket/flange surface interaction locations on the X-axis. Max. height on Y-axis is 20 µm and max. depth on Y-axis is 30 µm. RF width: ≈7.5 mm.

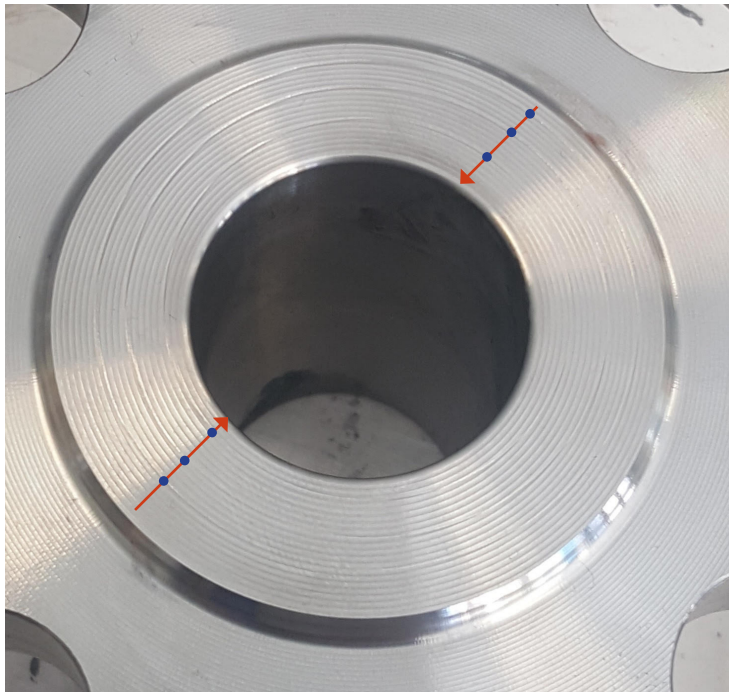
Figure 1. (Note: the gasket was not seated concentrically with the flange bore on this sample)

After disassembly, all flanges were sent to Sintef for evaluation. Sintef used an Alicona Imaging 3D optical-based metrology and imaging system to determine the impact of the DeltaV-Seal on the flange surfaces. Measurements were performed on two separate laterals 180 degrees apart across the complete RF width including the sealing areas of the three ridges marked out with blue spots, refer to Figure 1 below.

Below is reported the measured depth and width values at the location of the blue spots, i.e., where the ridges of the DeltaV-Seal interacted with the flange surfaces. The maximum depth of the six (6) measured values are reported.
