Imperfections on flange faces happen. With more and more companies adopting low emissions business practices, can damaged flange surfaces provide a suitable seal to meet environmental compliance?

## 1. Introduction

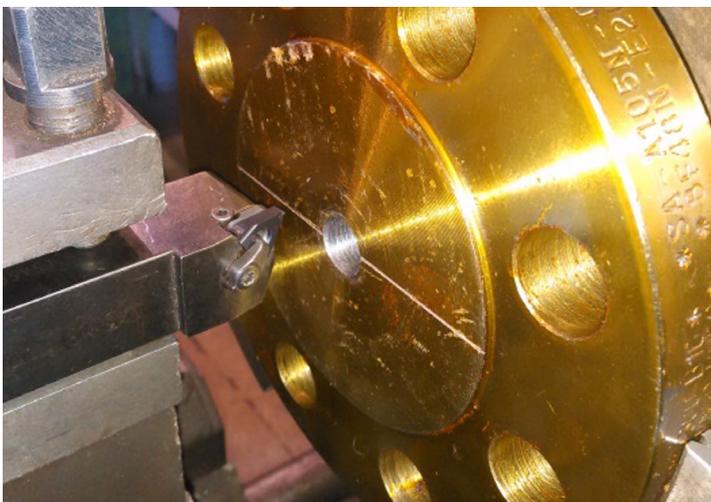
Figure 4 shows machining of the notch/flange imperfection to be used for leakage testing.

1. All flanges were chucked with 30 Newton in a manual lathe.
2. A 60° thread cutting tool with a radius of 0.1 mm was used for machining the imperfection.
3. A contact point was set between the tool and RF area of the blind flange.
4. Cutting depth of 0.1 mm was set on the top slider. Then the vertical slider was driven from the largest diameter towards the centre hole of the flange.
5. The chuck was turned 180° and the vertical slider was driven from the largest diameter towards the centre hole of the flange.
6. Above operations were repeated for two more blind flanges, but with notch depth of 0.2 mm and 0.3 mm respectively.

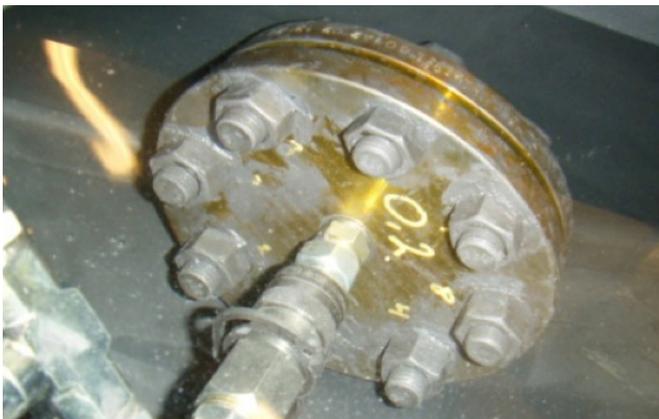
Figure 6 – Assembled test sample for gaseous helium testing (One flange with groove and one smooth flange)

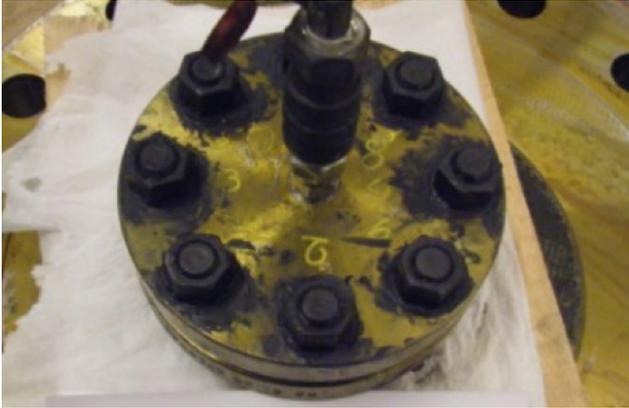
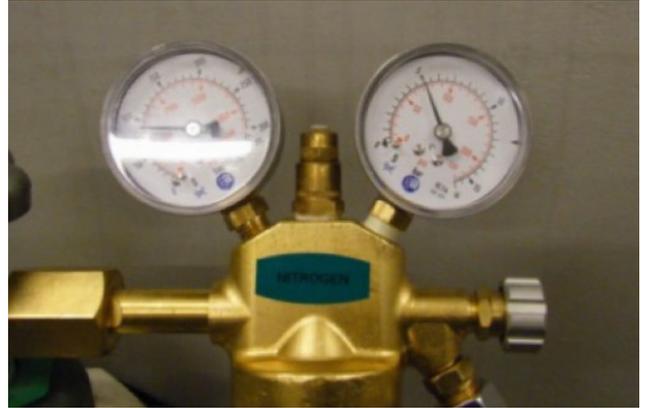
Pictures from testing of DeltaV-Seal with use of 0,1 mm damage

Figure 8. Helium test - 5 barg

Figure 9. Helium test - 5 barg

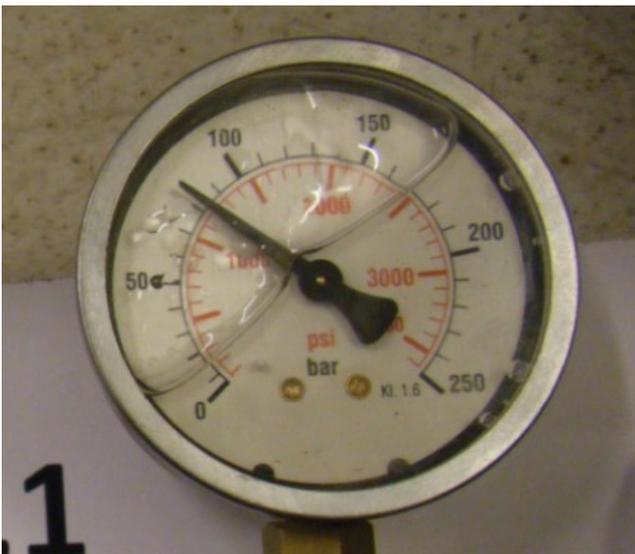
Figure 10. Water testing - 78 barg

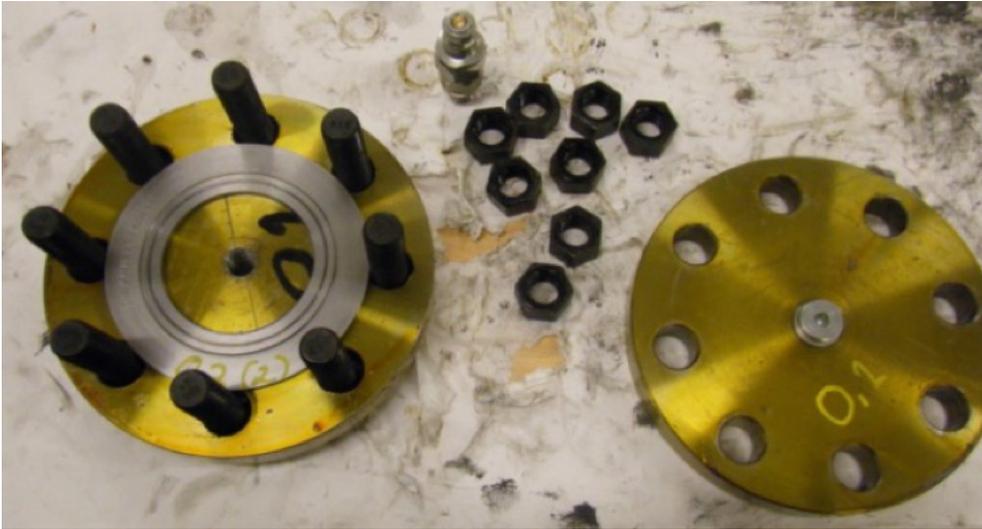
Pictures from testing of DeltaV-Seal with use of 0,2 mm damage

Figure 11. Assembly of test specimen

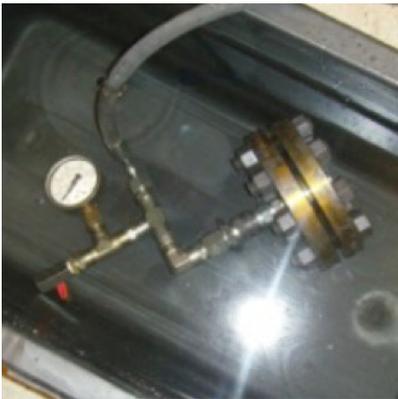
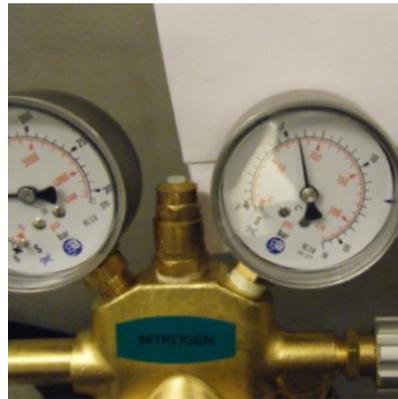
Figure 12. Helium testing - 5 barg

Figure 13. Helium testing - 5 barg

Figure 14. Helium testing - 5 barg

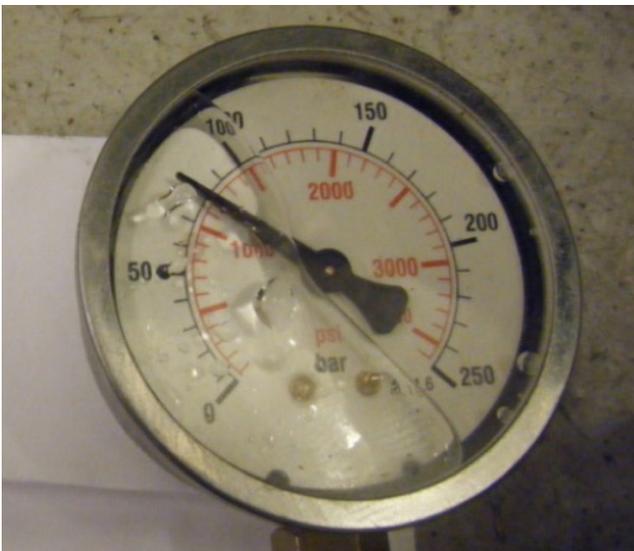
Figure 15. Water testing - 78 barg

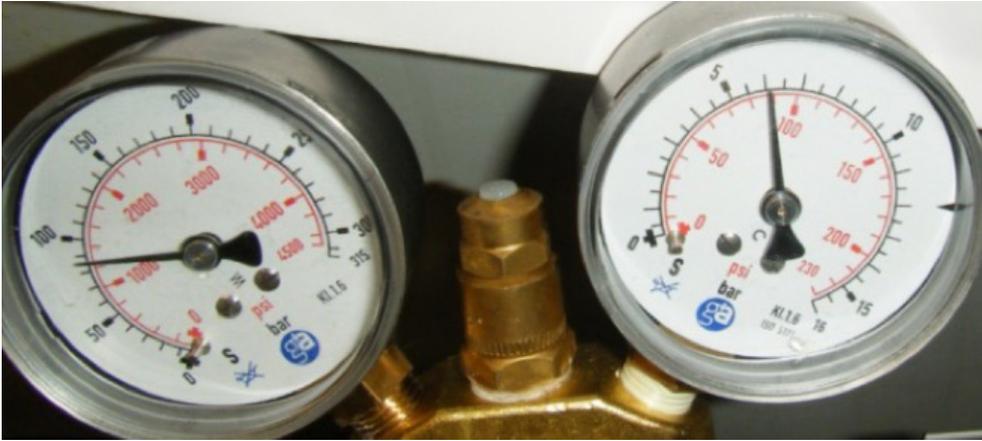
Pictures from testing of DeltaV-Seal with use of 0,3 mm damage

Figure 16. Helium testing - 5 barg

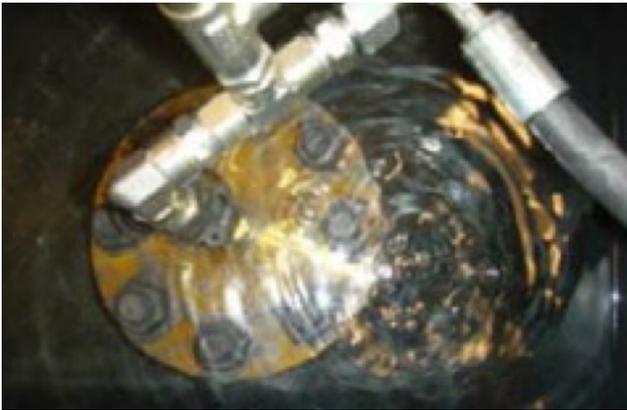
Figure 17. Helium testing - 5 barg - Leakage up to 95 Nm torque

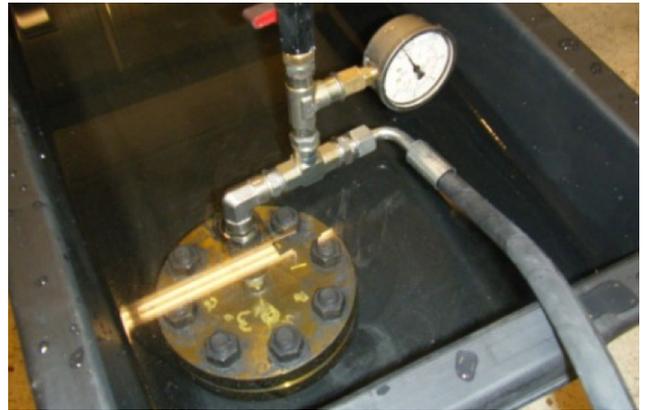
Figure 18. Helium testing - 5 barg - No detected leakage at 108 Nm torque

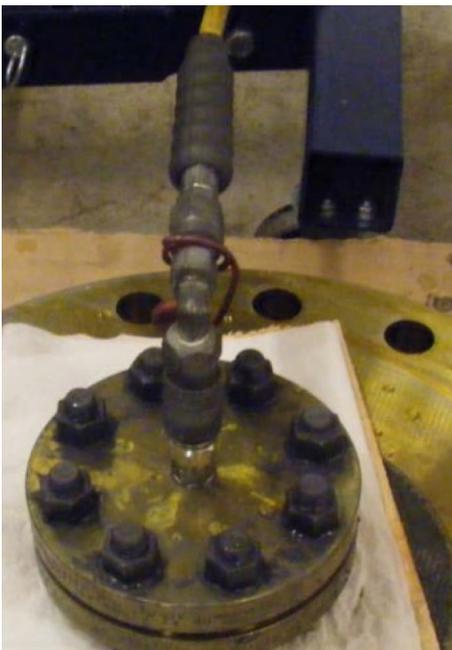
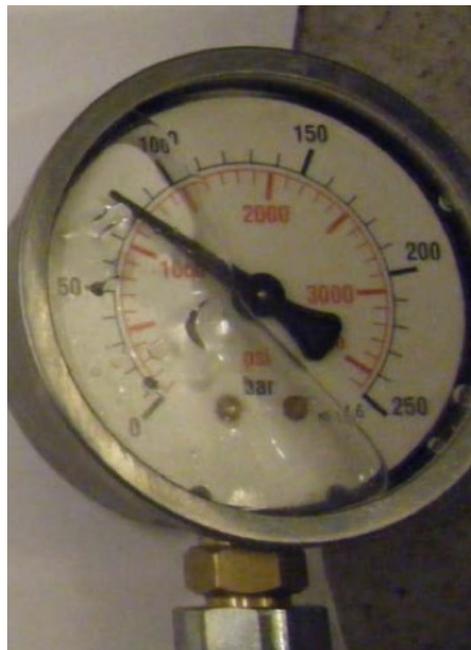
Figure 19. Water testing - 78 barg

Figure 20. Water testing - 78 barg
